# MARITIME HERITAGE MINNESOTA

## White Bear Lake Nautical Archaeology I Project Report

Ann Merriman  
Christopher Olson

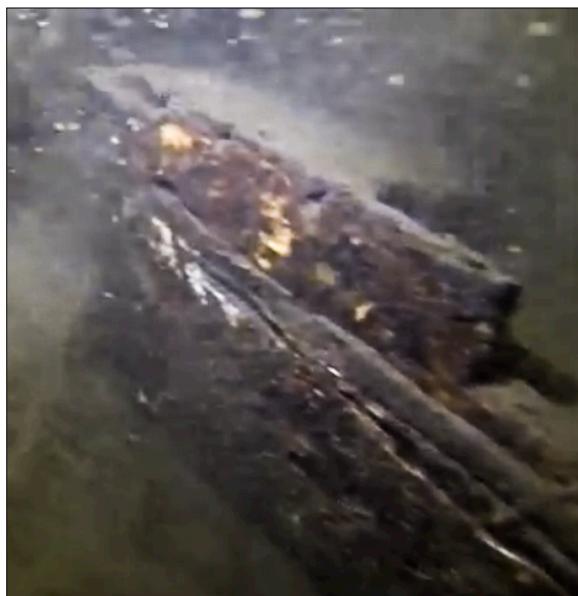
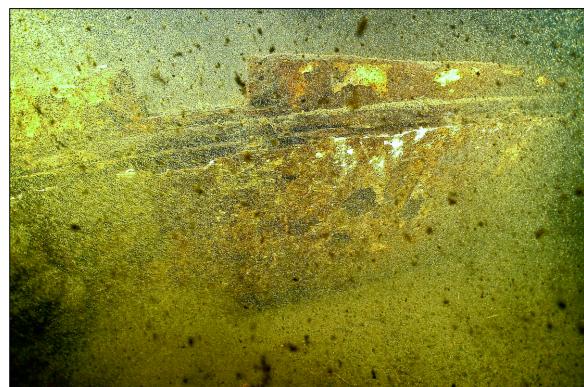
Above: The port side bow chock cut into the log rail (by Mark Slick).

Left: The port side reinforced bow and the chock cut into the log rail (by Kelly Nehowig).

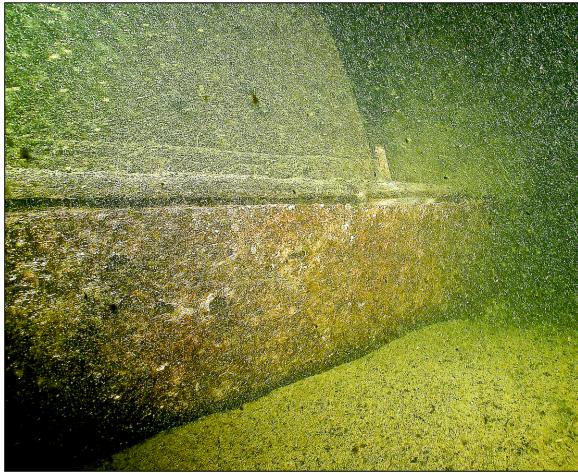
The port side of the wreck amidships showing where the windshield meets the gunwale and the log rail ends (by Mark Slick).

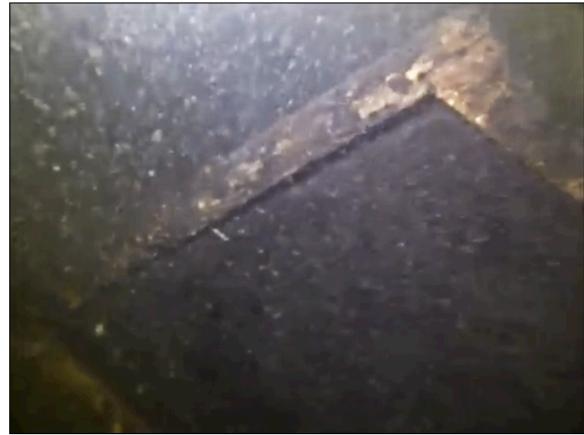
The port side top corner of the windshield frame with the port side glass (by Kelly Nehowig).

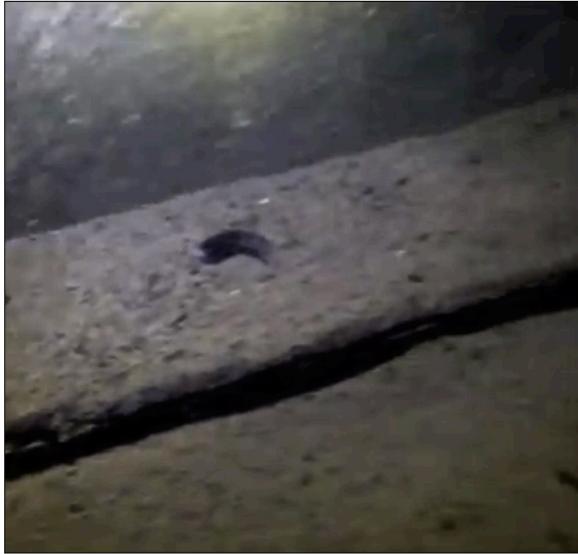
A hole in the amidships port side gunwale that held the flagpole for the Judge's Boat flag (by Kelly Nehowig).

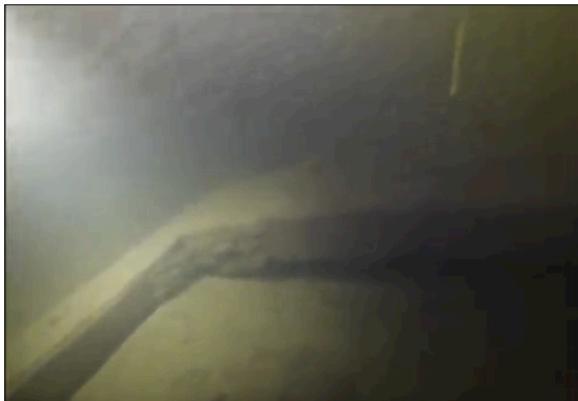
The starboard stern of the Judge's Boat Wreck (by Kelly Nehowig).

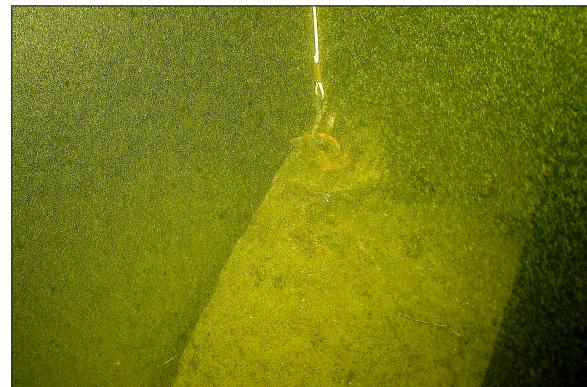
The stern deck with the lifting eye attached (by Mark Slick).

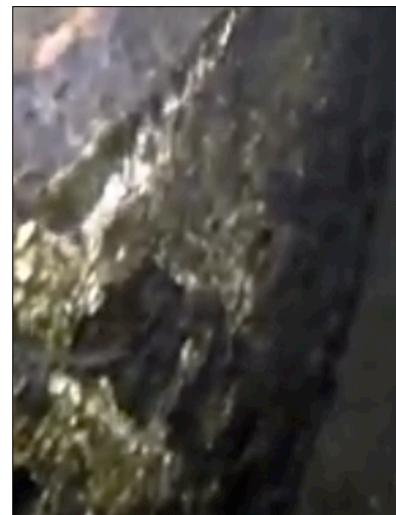
Above and Right: The "W B" and "B Y" on the wreck's transom (by Kelly Nehowig).

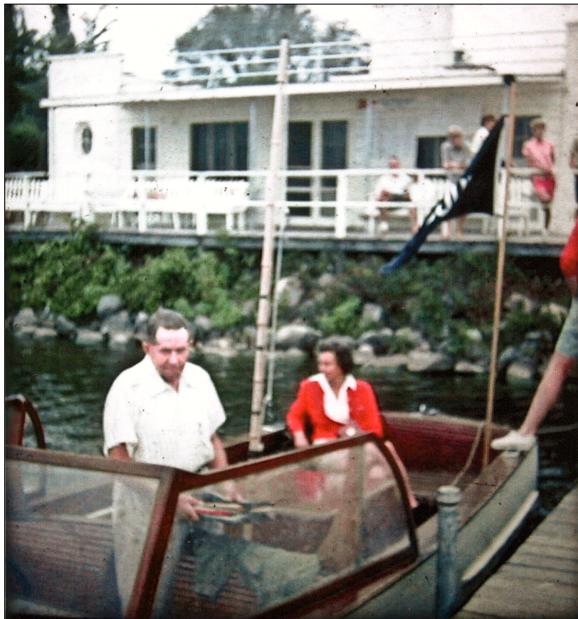
The Judge's Boat Wreck (21-WA-113) docked at the WBYC Sailor's Pavilion, constructed in 1939. The man in the Judge's Boat is Eugene Markoe (courtesy of James Warner through the White Bear Area Historical Society; Sara Markoe Hanson, personal communication, September 9, 2014).

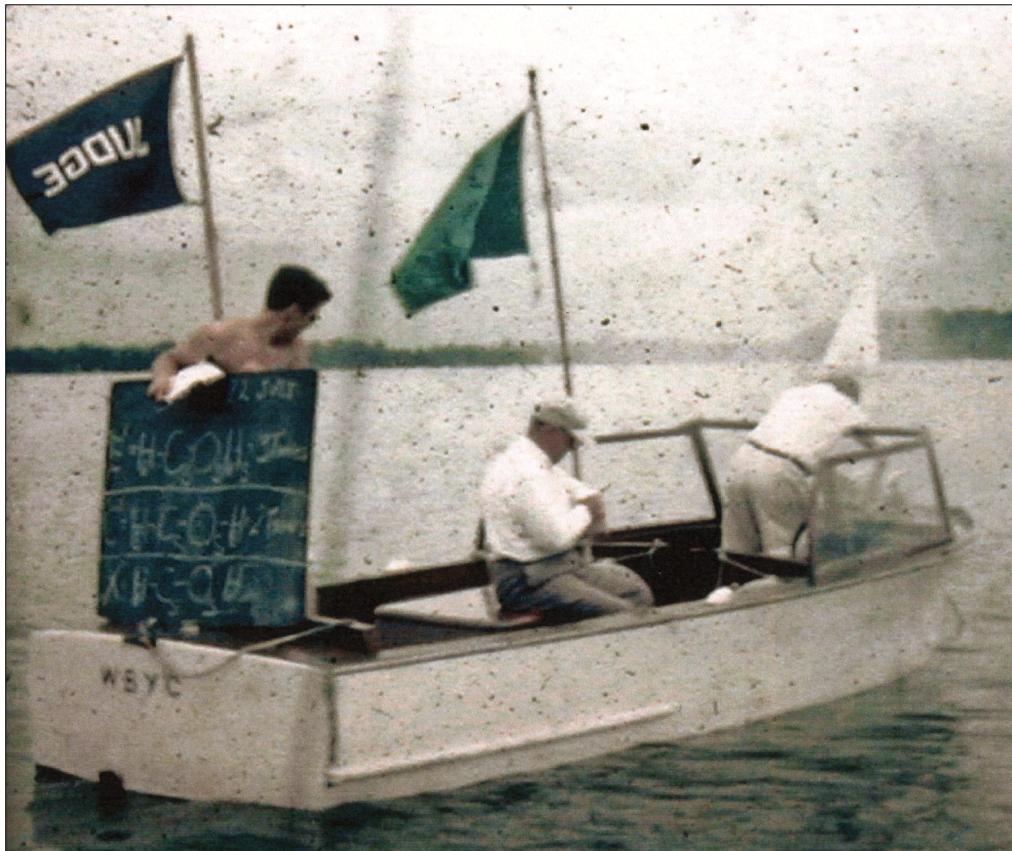
The Judge's Boat Wreck on the water, over-seeing a sailing regatta. Eugene Markoe is tending the small starter's cannon at the bow (courtesy James Warner through the White Bear Area Historical Society).

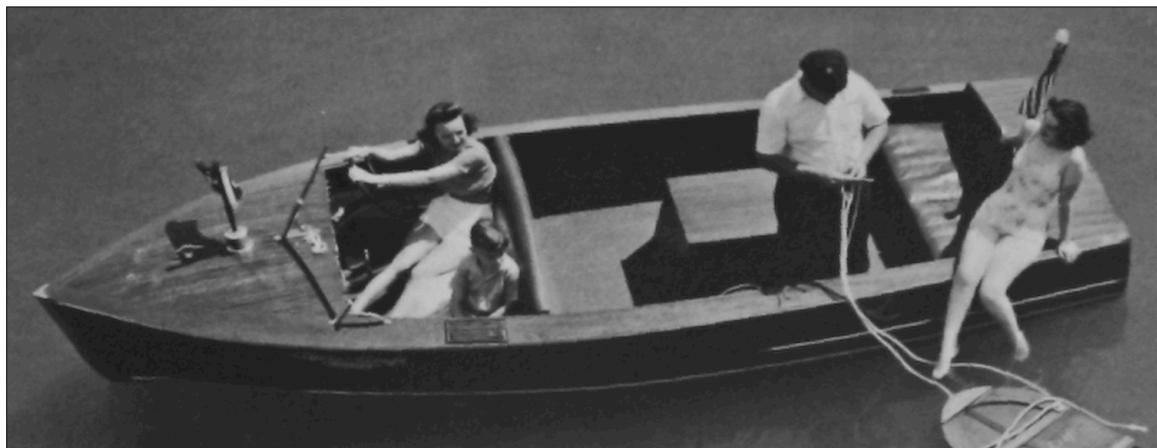
A 1941-1942 Chris Craft Deluxe Utility model as manufactured. The Judge's Boat Wreck was modified by her first owner Vic Hauser or the WBYC in several ways: the addition of the bow log rail and a reinforced stempost; the attachment of the starter's cannon; a larger windshield; the step pads were removed; flagpole holes and a pole bracket were added to the gunwale; the front bench was replaced by two wooden slat seats; the stern bench was replaced by a wooden slat bench; the stern eye was reinforced with an extra wooden block; and she was painted white with the number "9" affixed to her hull (Mariner's Museum PI 1995).

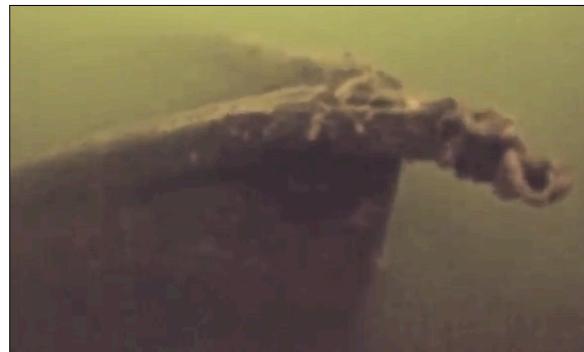
The Steel Boat Wreck 1 showing a metal strap extending off the bow for towing or lifting (by Mark Slick).

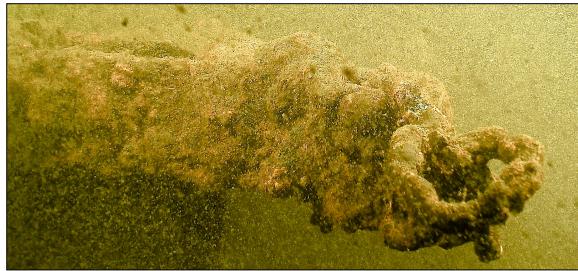
The shackle attached to the metal strap of 21-WA-114 (by Mark Slick).

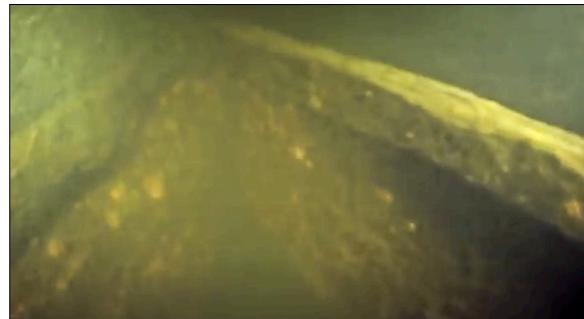
The bow of the wreck viewed from inside showing the wooden gunwale stringer (by Mark Slick).

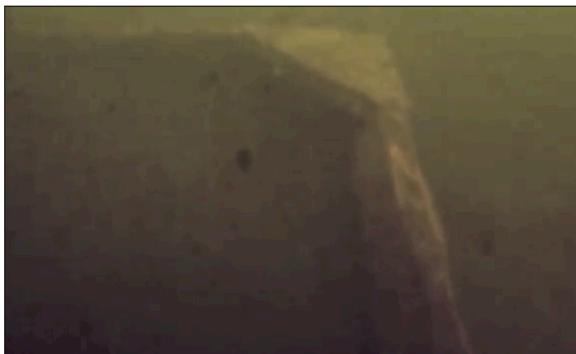
The starboard side stern reinforcement (by Mark Slick).

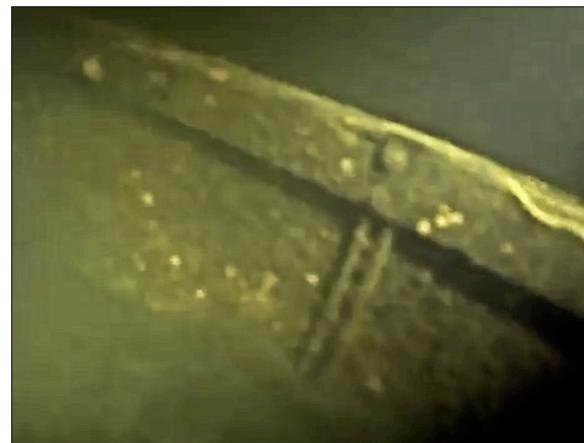
A starboard side channel frame attached to the inner hull (by Mark Slick).

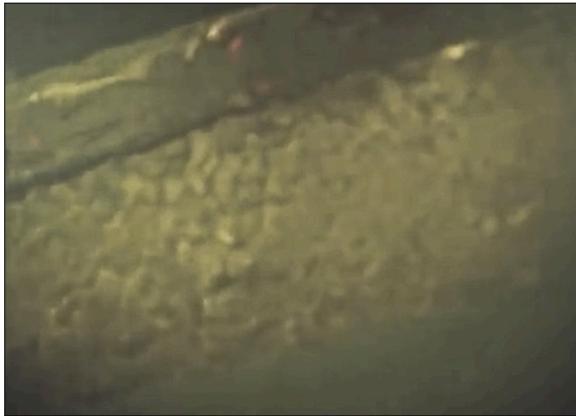
The outer hull of the Steel Boat Wreck 1 with some red paint on the wooden gunwale (by Mark Slick).

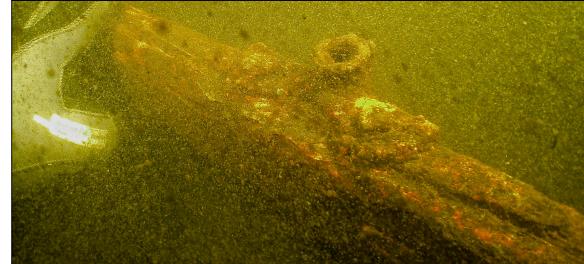
An oarlock attached to the port side of the wreck, surrounded by the gunwale stringer, painted red like the gunwale (by Mark Slick).

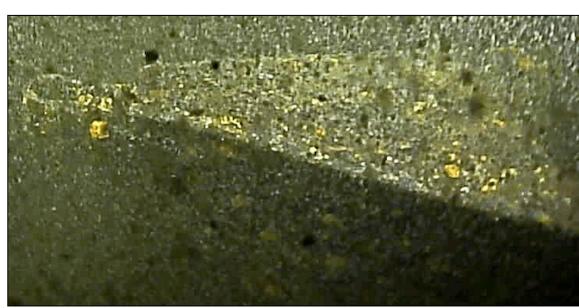
The bow of the Steel Boat Wreck 2 (by Mark Slick).

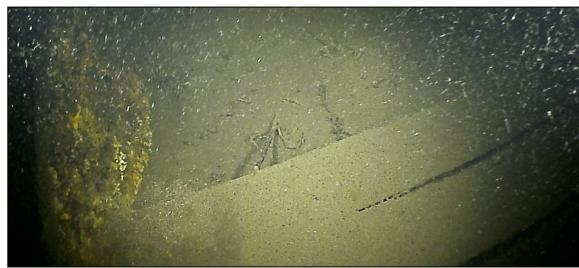
The wreck's rear wooden seat (by Mark Slick).

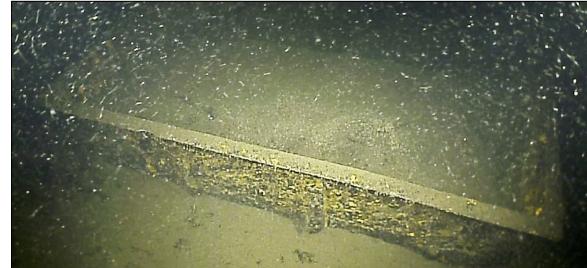
The stern gunwale with the outboard transom board (by Mark Slick).

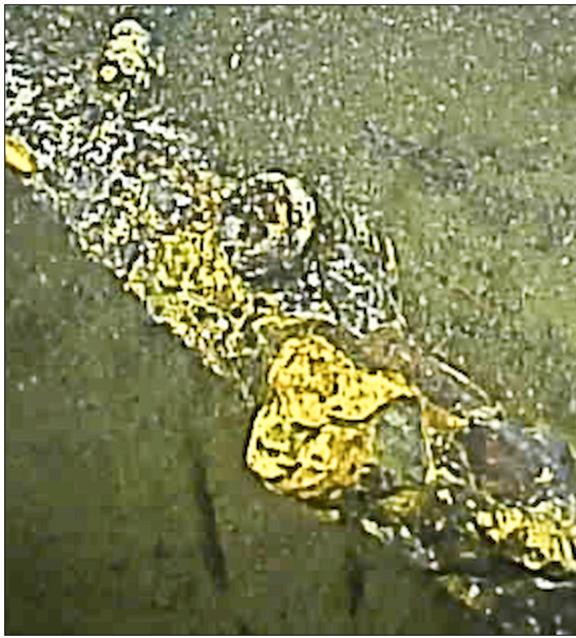
An oarlock on the Steel Boat Wreck 2 (by Mark Slick).

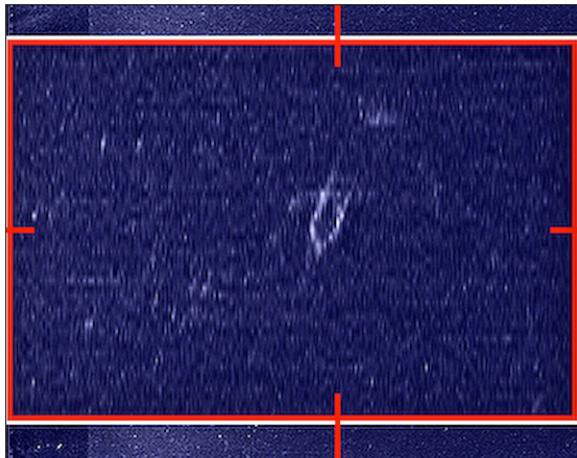
A sonar image of the Aluminum Square Stern Canoe Wreck (Anomaly 12), an unusual craft.

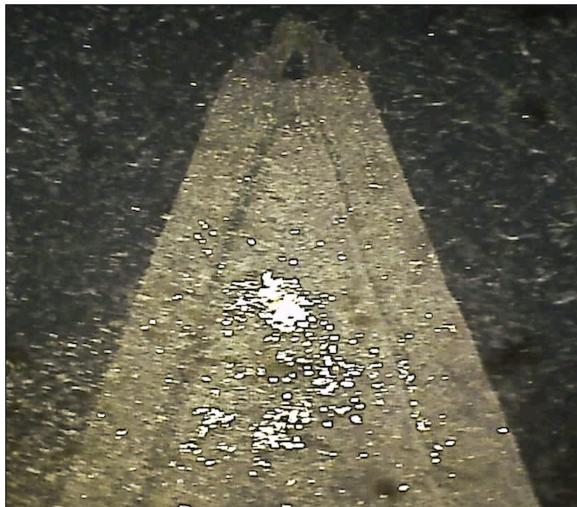
The bow of the Anomaly 12 (by Mark Slick).

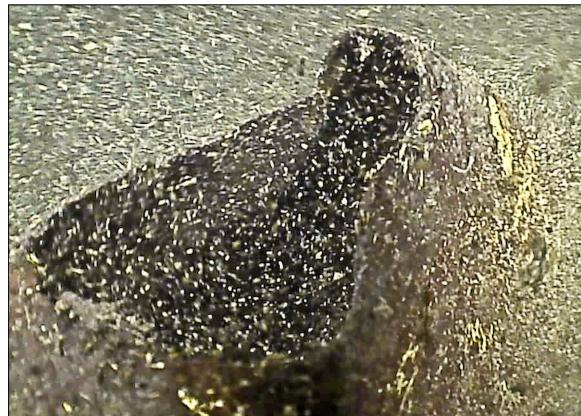
Damage to the canoe's bow (by Mark Slick).

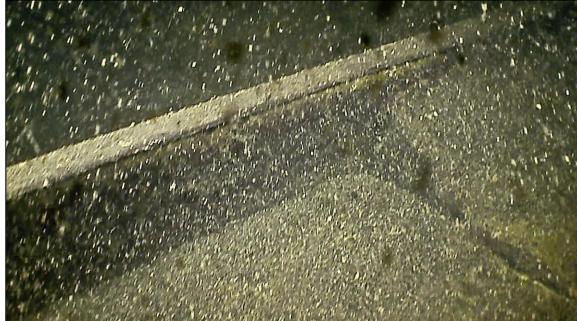
The port side gunwale and front seat (by Mark Slick).

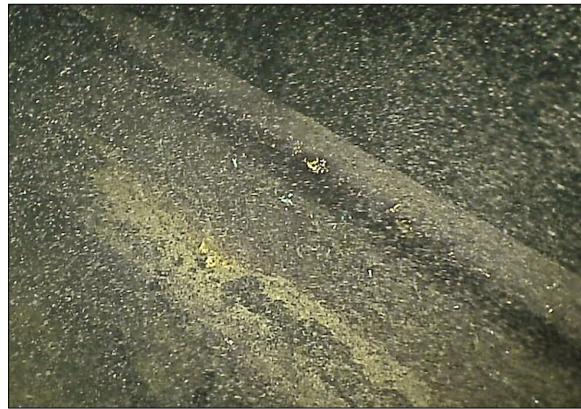
The starboard side splash rail amidships (by Mark Slick).

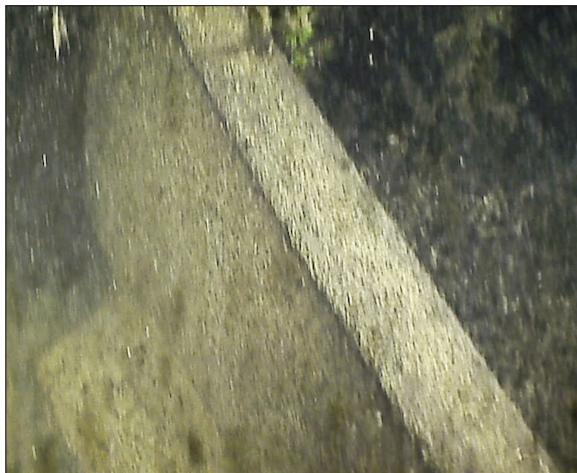
The starboard stern quarter of the Aluminum Square Stern Canoe Wreck where the splash rail is at its largest (by Mark Slick).

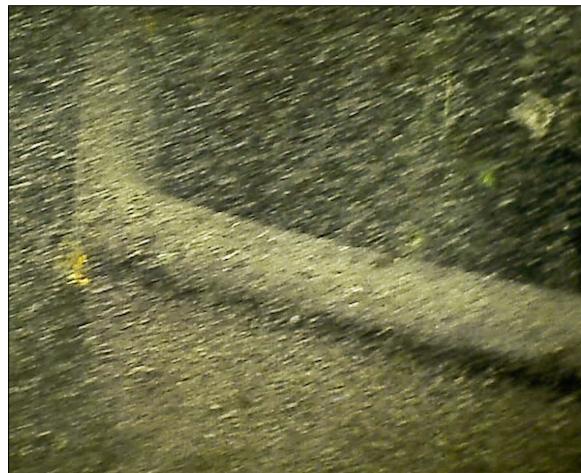
The starboard stern quarter and transom with a lifting or tie-down eye attached (by Mark Slick).

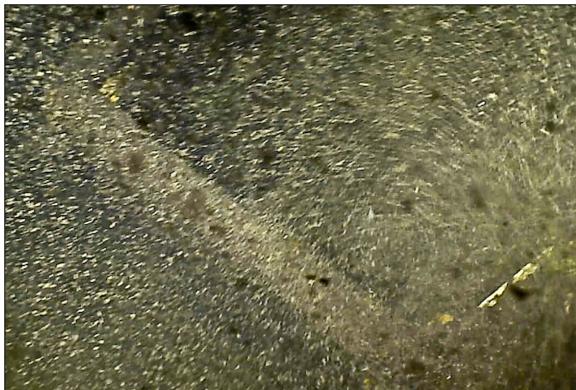
The narrow nature of the Aluminum Square Stern Canoe Wreck at the stern is evident in this image  
(by Mark Slick)

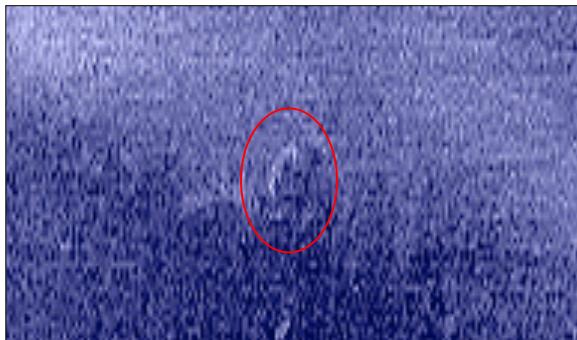
Above: A sonar image of Anomaly 28, the Mast and Sail.

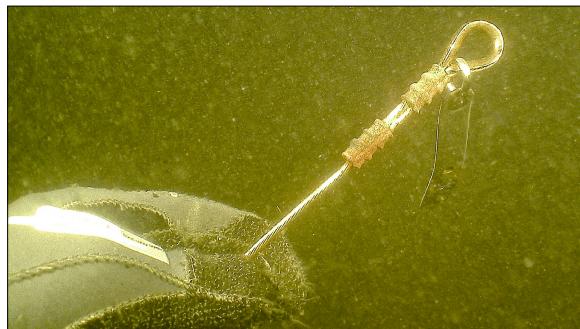
A galvanized steel cable with a loop (by Mark Slick).

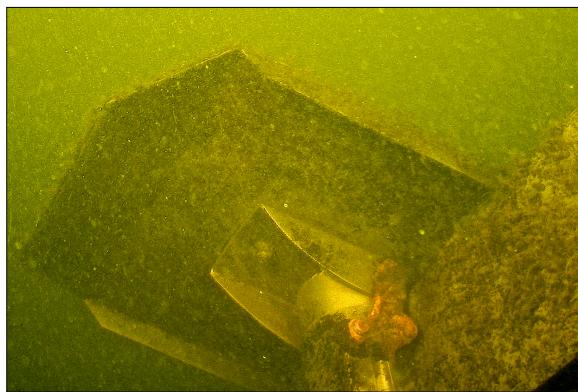
A Boat Lift sandpad (by Mark Slick).

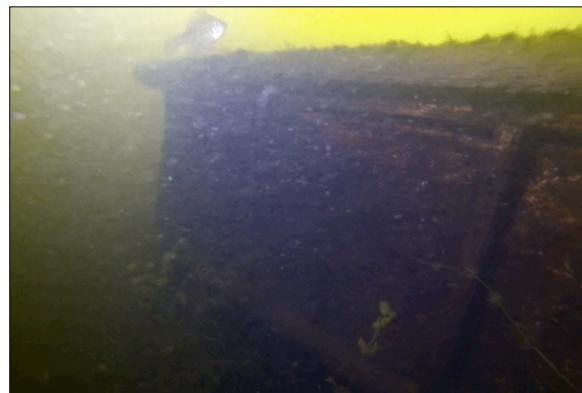
A corner of Anomaly 14 (by Kelly Nehowig).

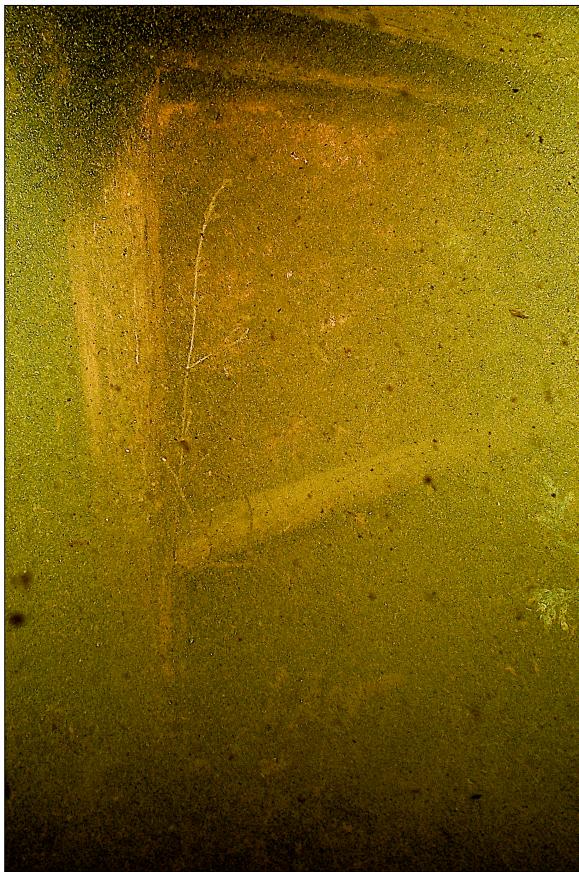
A corner of the Ice Fishing House (by Mark Slick).

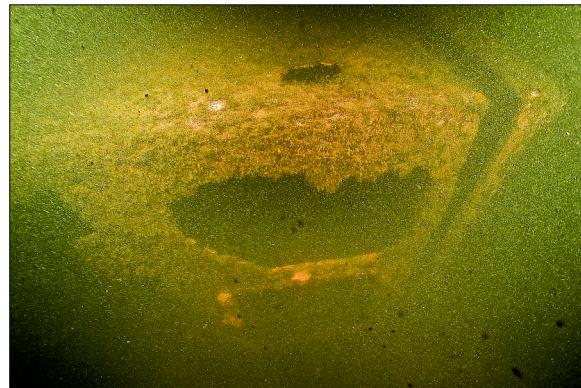
A corner of Anomaly 14 showing extensive damage to its plywood sides (by Mark Slick).

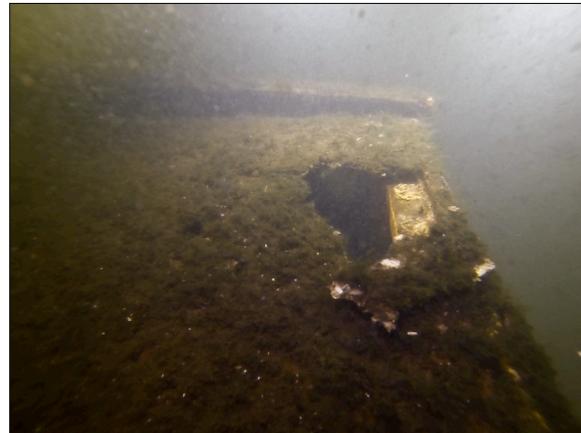
A corner of the Ice Fishing House that shows the sturdy wooden frame under the plywood (by Kelly Nehowig).
